**Flood Control Project Maintenance
Levee Inspections**

Maintenance Issue Types Only, Levee Inspection Report By Mile - Spring 2020

Reclamation District No. 0150 Merrit Island

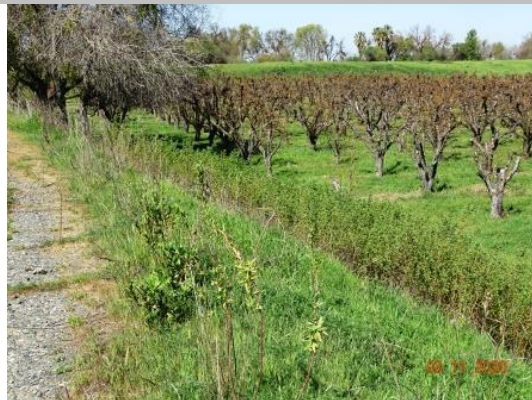
Photo 1 of 1 : SP_2020_RD0150_15_1_20200313_00003.jpg

LM Start	0.04	Rating **	M	Issue No.	1
LM End	0.04	Issue Type +	Ma	Location *	LS
Category	Earthen Levee			GPS Latitude/Longitude	
				Start	End
Item	Vegetation			38.332478 °	38.332478 °
				-121.582798 °	-121.582798 °
DWR ID	DWR_RD0150_01_s_2020_1				
Comment Code					
V2 : Remove the wild growth other than native grasses from the levee slopes.					
Inspector Comment

View of wild growth on the landside slope. Spring 2020

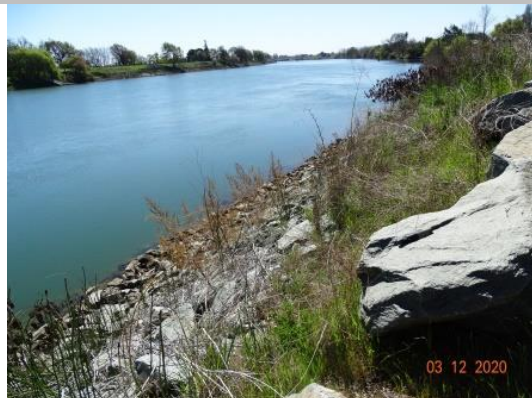
Photo 1 of 4 : SP_2020_RD0150_16_46_20200403_00016.jpg

LM Start	0.11	Rating **	A/W	Issue No.	46
LM End	0.14	Issue Type +	Ma	Location *	WS
Category	Earthen Levee			GPS Latitude/Longitude	
				Start	End
Item	Erosion / Bank Caving			38.329369 °	38.329767 °
				-121.574936 °	-121.574589 °
DWR ID	LMA-112				
Comment Code					
E1 : Note and monitor erosion site.					
Inspector Comment					
Riprap on the upper slope of LM 0.14 near the private dock appears to be intact. The 2017 flood damage consists of a waterside erosion approximately 185 feet long on the west (right) bank of the Sacramento River. The crown is a paved road. Scarps are up to 3 ft deep but are not fully vertical. Monitor this stie, because the erosion is not very deep into prism. Site ID No:286 Site Designation:LMA-112

View of riprap placed near the dock at LM 0.14. Spring 2020

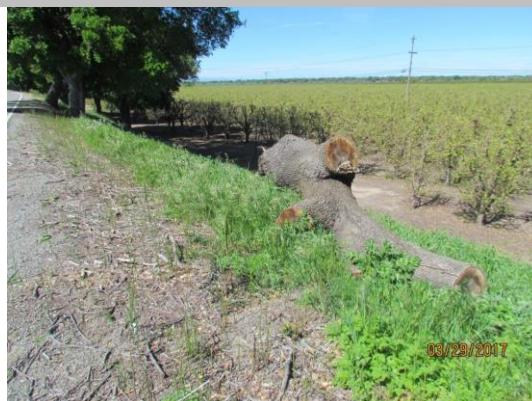
Photo 1 of 1 : SP_2020_RD0150_16_63_20200403_00041.jpg

LM Start	2.10	Rating **	M	Issue No.	63
LM End	2.10	Issue Type +	Ma	Location *	LS
Category	Earthen Levee			GPS Latitude/Longitude	
				Start	End
Item	Encroachments			38.347002 °	38.347002 °
				-121.547803 °	-121.547803 °
DWR ID	DWR_RD0150_02_f _ 2016_63				
Comment Code					
TR : Tree or limb					
Inspector Comment

Remove the log from the landside slope of the levee.

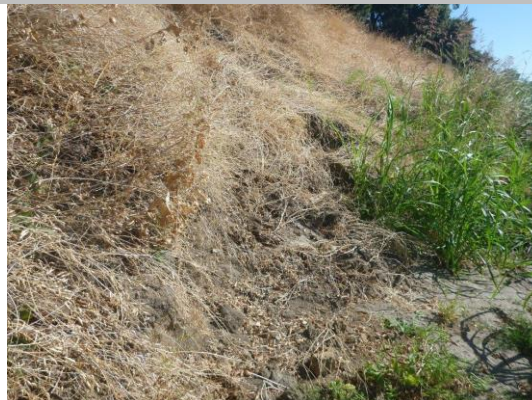
Photo 1 of 3 : LEVAL_SP_2020_287_2143.jpg

The flood damage consists of a waterside erosion approximately 229 feet long on the west (right) bank of the Sacramento River.

The crown is a paved road. There are erosion scarps up to 10 ft deep and within 5 ft of the crown. Worse conditions are on the DS end. There is exposed filter fabric. This erosion is serious, because of depth of erosion into the levee, weak soil, and proximity to the crown which is a high traffic public road. The slope appears to be intact to at least 5-10' from the levee shoulder.

Planned For Repair.

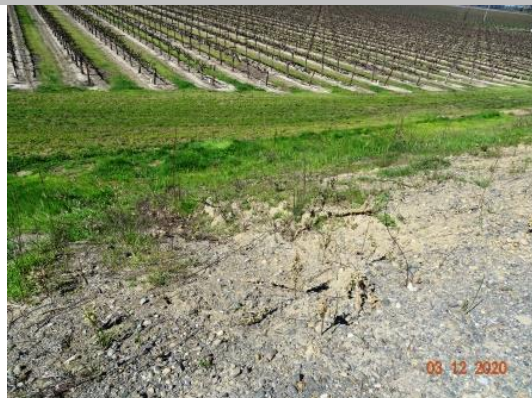
Photo 2 of 2 : SP_2020_RD0150_16_81_20200403_00051.jpg

LM Start	4.18	Rating **	M	Issue No.	81
LM End	4.18	Issue Type +	Ma	Location *	LS
Category	Earthen Levee			GPS Latitude/Longitude	
				Start	End
Item	Erosion / Bank Caving			38.366222 °	38.366222 °
				-121.522423 °	-121.522423 °
DWR ID	DWR_RD0150_02_s_2020_81				
Comment Code					
E2 : Schedule repair of erosion site prior to the next inspection.					
Inspector Comment

View of erosion on the landside slope due to runoff. Spring 2020

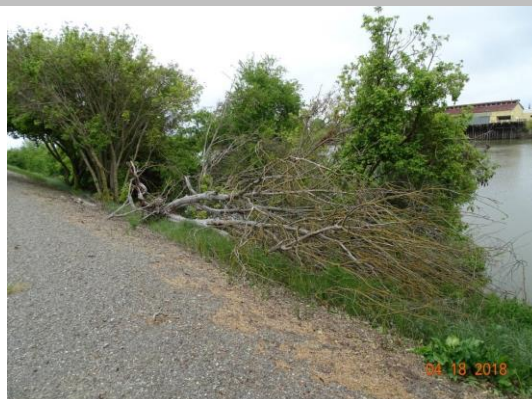
Photo 1 of 1 : SP_2020_RD0150_16_107_20200403_00058.jpg

LM Start	4.27	Rating **	M	Issue No.	107
LM End	4.27	Issue Type +	Ma	Location *	WS
Category	Earthen Levee			GPS Latitude/Longitude	
				Start	End
Item	Encroachments			38.367507 °	38.367507 °
				-121.522493 °	-121.522493 °
DWR ID	DWR_RD0150_02_s_2018_107				
Comment Code					
TR : Tree or limb					
Inspector Comment					
Remove a fallen tree on the waterside slope.

View of fallen tree on waterside looking northeast. Spring 2018

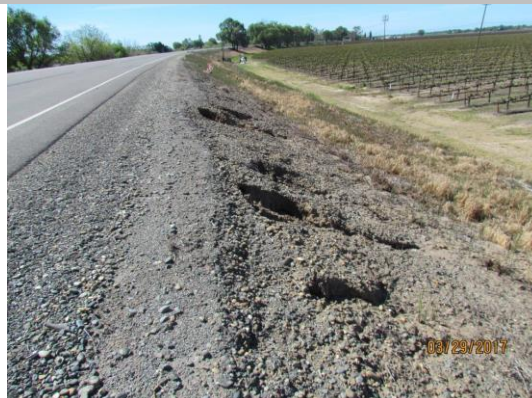
Photo 2 of 2 : SP_2020_RD0150_16_52_20200403_00029.jpg

LM Start	5.90	Rating **	M	Issue No.	52 (cont)
LM End	5.90	Issue Type +	Ma	Location *	LS
Category	Earthen Levee			GPS Latitude/Longitude	
				Start	End
Item	Erosion / Bank Caving			38.387915 °	38.387915 °
				-121.516002 °	-121.516002 °
DWR ID	DWR_RD0150_02_f_2016_52

View of the erosion on the landside of the levee during spring 2017 inspection.

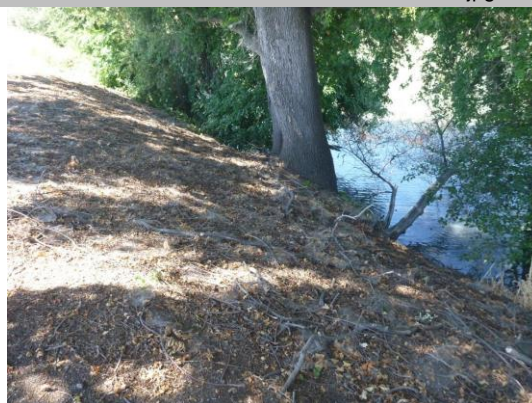
Photo 1 of 3 : LEVAL_SP_2020_297_1928.jpg

LM Start	2.72	Rating **	M	Issue No.	42
LM End	2.73	Issue Type +	Ma	Location *	WS
Category	Earthen Levee			GPS Latitude/Longitude	
				Start	End
Item	Slope Stability			38.359256 °	38.359461 °
				-121.561239 °	-121.561275 °
DWR ID	LMA-123				
Comment Code					
S1 : Repair slope instability.					
Inspector Comment					
This was a 2017 Storm Damage site. On 11 and 15 January 2017, waterside instability and cracking were observed on the east (left) bank of Elk Slough. The site is approximately 75 feet long and 5 to 10 feet down from the levee crest. Site ID No:297 Site Designation:LMA-123

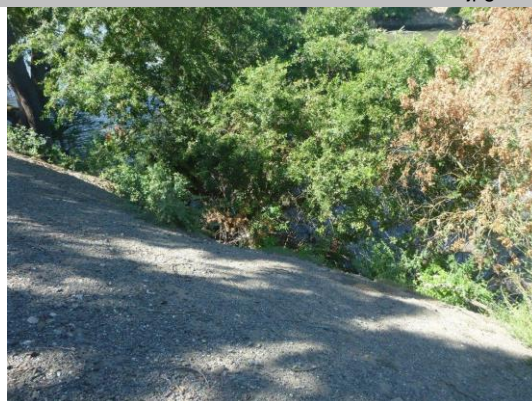
Photo 1 of 3 : LEVAL_SP_2020_299_2105.jpg

LM Start	2.80	Rating **	M	Issue No.	53
LM End	2.80	Issue Type +	Ma	Location *	WS
Category	Earthen Levee			GPS Latitude/Longitude	
				Start	End
Item	Slope Stability			38.360367 °	38.360367 °
				-121.561592 °	-121.561592 °
DWR ID	LMA-125				
Comment Code					
S1 : Repair slope instability.					
Inspector Comment					
On 11 January 2017, waterside instability and cracking were observed on the east (left) bank of Elk Slough. The site is approximately 70 feet long and 12 feet down from the levee crest. Site ID No:299 Site Designation:LMA-125 Crown is a paved road. Cracking on upper 1/3 of slope. Lower 1/2 of slope is near vertical. Area of concern because erosion is less severe than other sites along Elk Slough.

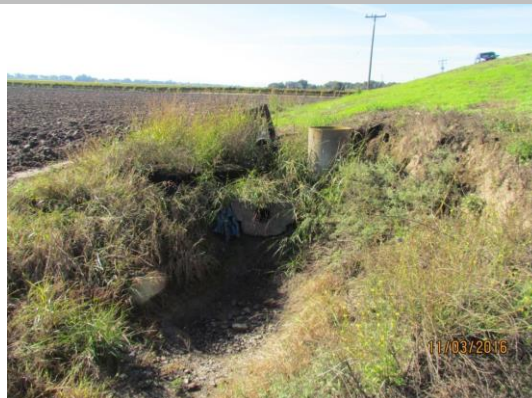
Photo 1 of 2 : SP_2020_RD0150_17_115_20200302_00079.jpg

View of the ditch on the landside toe of the levee. Fall 2016

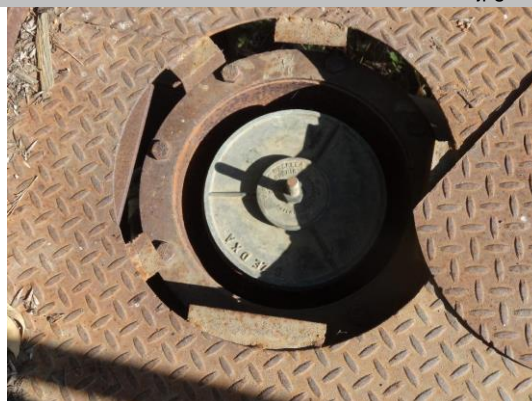
Photo 3 of 3 : UCIP_SP_2020_49386_63900.jpg

WS view: siphon breaker on pipe in steel deck on stream bank.

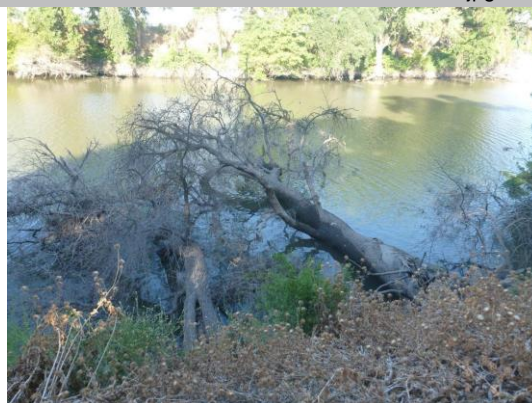
Photo 1 of 2 : LEVAL_SP_2020_309_2036.jpg

2 oak trees fell over at the WS toe and took root balls out of the lower slope about 5 ft deep just above the water line. Area of concern because damage is only on the lower slope near the water line.

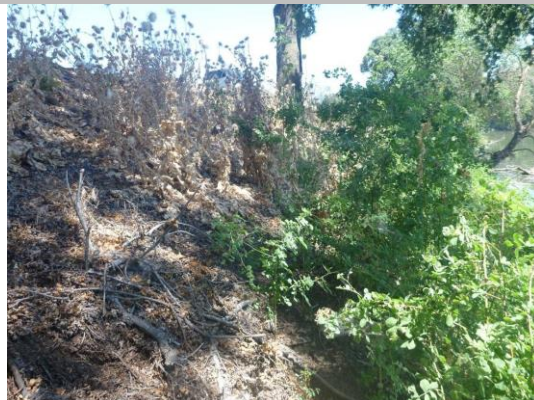
Photo 1 of 3 : LEVAL_SP_2020_310_2188.jpg

Comment Code					
Inspector Comment					
Planned For Repair.					
Levee Evaluation Comments					
Description:Cracking and erosion were observed on the waterside levee slope on the east (left) bank of Elk Slough. The site is approximately 40 feet long. See attached pages for photos.					
Site ID No:310					
Site Designation:LMA-136					
Repair Type: Erosion					
Rating:Serious					
Field Date:7/17/2017					
Notes: Large oak tree fell over here and took a root ball with it. At least 15 ft wide by 5ft deep soil missing, 5 ft from crown. Longitudinal cracks for 40 ft along crown hinge. Serious because prism is impacted and cracking is visible beyond the damaged area.

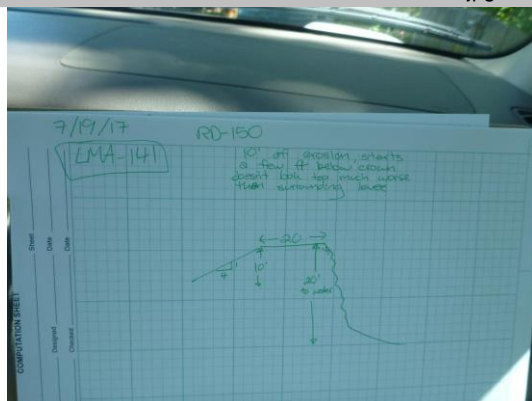
Photo 3 of 3 : LEVAL_SP_2020_314_2324.jpg

LM Start	6.95	Rating **	A/W	Issue No.	121 (cont)
LM End	6.95	Issue Type +	Ma	Location *	WS
Category	Earthen Levee			GPS Latitude/Longitude	
				Start	End
Item	Erosion / Bank Caving			38.397197 °	38.397225 °
				-121.535089 °	-121.535092 °
DWR ID	LMA-141

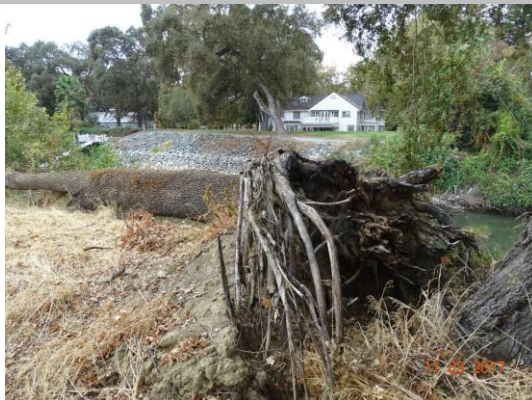
Photo 1 of 1 : SP_2020_RD0150_17_129_20200302_00094.jpg

LM Start	7.75	Rating **	M	Issue No.	129
LM End	7.75	Issue Type +	Ma	Location *	WS
Category	Earthen Levee			GPS Latitude/Longitude	
				Start	End
Item	Encroachments			38.406298 °	38.406298 °
				-121.542939 °	-121.542939 °
DWR ID	DWR_RD0150_03_f_2017_129				
Comment Code					
TR : Tree or limb					
Inspector Comment					
Remove a fallen tree from the waterside shoulder of the levee, and fill any large void.

View of a tree stump on the waterside shoulder of the levee. Fall 2017

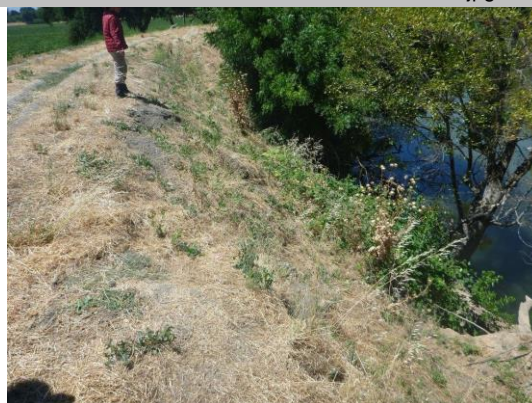
Photo 1 of 3 : LEVAL_SP_2020_316_2180.jpg

LM Start	8.35	Rating **	A/W	Issue No.	123
LM End	8.35	Issue Type +	Ma	Location *	WS
Category	Supplemental			GPS Latitude/Longitude	
				Start	End
Item	2017 Storm Damage			38.407983 °	38.407992 °
				-121.534322 °	-121.534289 °
DWR ID	LMA-143				
Comment Code					
Inspector Comment					
Planned For Repair.					
Levee Evaluation Comments					
Description: Erosion was observed on the waterside levee slope on the east (left) bank of Elk Slough. The site is approximately 10 feet long.					
See attached pages for photos.					
Site ID No:316					
Site Designation:LMA-143					
Repair Type: Erosion					
Rating: Serious					
Field Date:7/17/2017					
Notes: 3 large trees in/adjacent to site including a fallen tree in the middle of the erosion. Erosion on almost the whole slope, but doesn't cut into the crown. Serious because erosion cuts into levee significantly here.

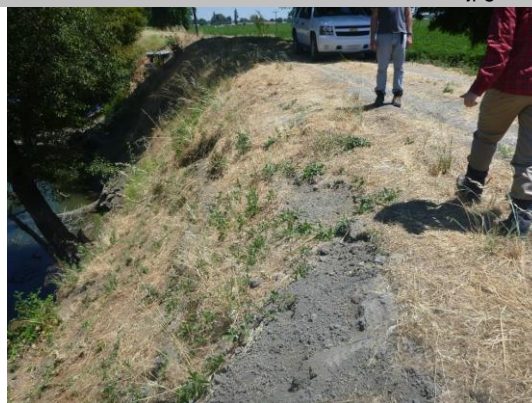
Photo 2 of 3 : LEVAL_SP_2020_316_2181.jpg

LM Start	8.35	Rating **	A/W	Issue No.	123 (cont)
LM End	8.35	Issue Type +	Ma	Location *	WS
Category	Supplemental			GPS Latitude/Longitude	
				Start	End
Item	2017 Storm Damage			38.407983 °	38.407992 °
				-121.534322 °	-121.534289 °
DWR ID	LMA-143

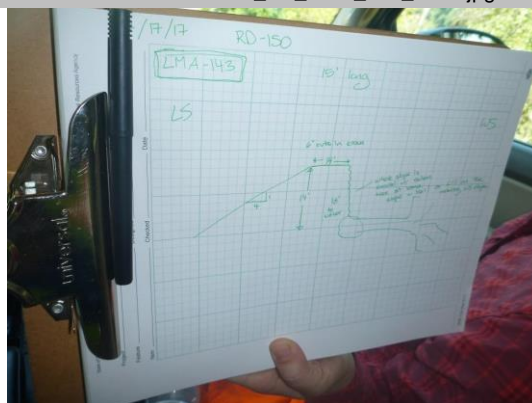
Photo 3 of 3 : LEVAL_SP_2020_316_2182.jpg

LM Start	8.35	Rating **	A/W	Issue No.	123 (cont)
LM End	8.35	Issue Type +	Ma	Location *	WS
